# RB 300 Series to Sea Water Volute

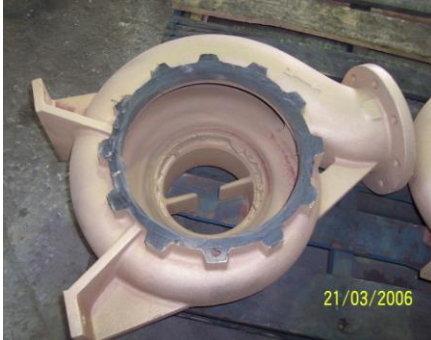
After masking and abrasive blasting

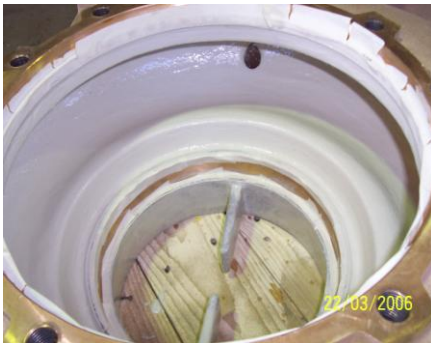
Re-mask and coating application

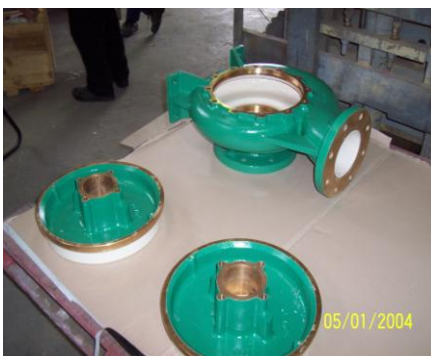
After external coating application
