<b>Client:</b> <i>Sea Tank Chartering AS.</i>	<b>Industry:</b> <i>Marine</i>
<b>Vessel:</b> <i>Chemical Tanker</i>	<b>Date:</b> <i>April 2016</i>
<b>Location:</b> <i>Poland</i>	<b>Products:</b> <i>Chem-tect™ RB 300 Series</i>

## Overview

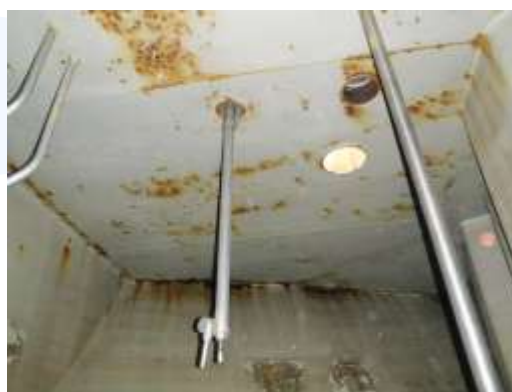
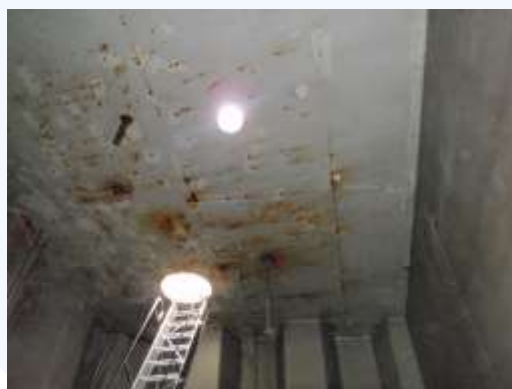
1

The original coating located in the chemical cargo tanks onboard the chemical tanker had failed. The tanks were therefore suffering from severe corrosion damage and had to be refurbished.

- Nos. 1-2 Original Conditions
- No. 3 After Grit Blasting

The cargo tanks were grit blasted to Sa 2½ standard. This was followed by one stripe coat and two full coats of **Chem-tect™ RB 300**. To complete the coating system, one topcoat of **Chem-tect™ RB 300TC** was applied.

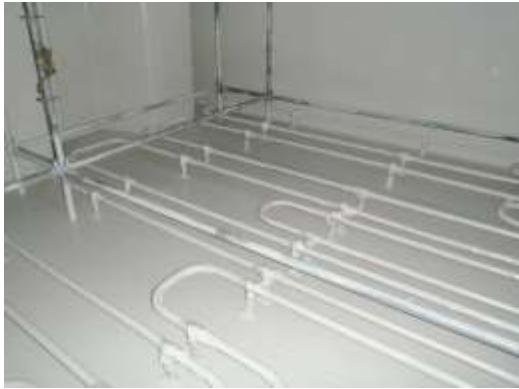
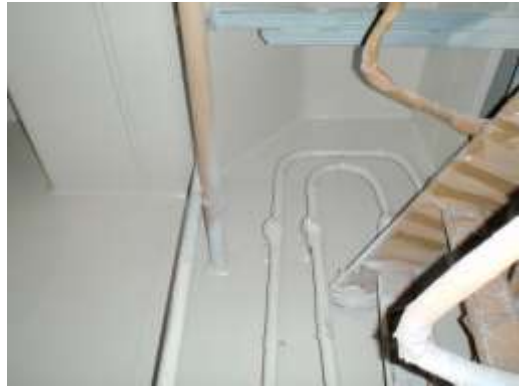
4

- Nos. 4-5 After Application of RB 300
- Nos. 6-9 Completed Application
