Client: <i>Sea Tank Chartering AS.</i>	Industry: <i>Marine</i>
Vessel: <i>MT Key Bora</i>	Date: <i>April 2016</i>
Location: <i>Poland</i>	Products: <i>Chem-tect™ RB 300 Series</i>

The original coating located in the chemical cargo tanks onboard the MT Key Bora chemical tanker had failed. The tanks were therefore suffering from severe corrosion damage and had to be refurbished.

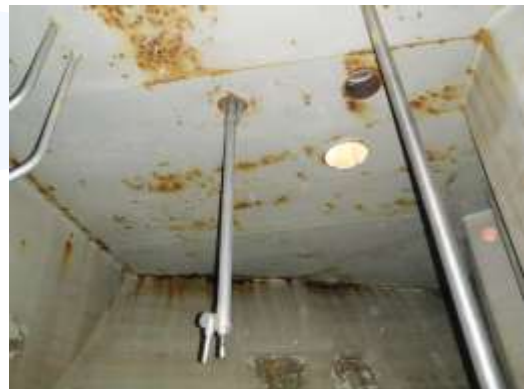
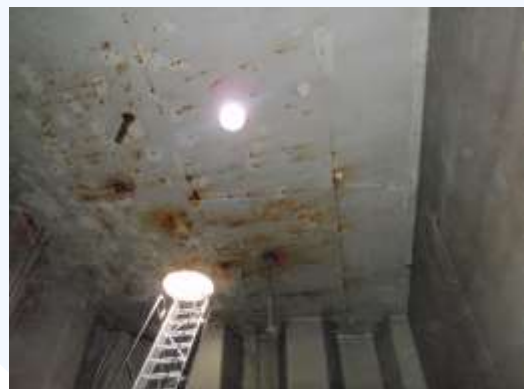
- Nos. 1-2 Original Conditions
- No. 3 After Grit Blasting

The cargo tanks were grit blasted to Sa 2½ standard. This was followed by one stripe coat and two full coats of **Chem-tect™ RB 300**. To complete the coating system, one topcoat of **Chem-tect™ RB 300TC** was applied.
