<b>Client:</b> <i>School (Sports Hall)</i>	<b>Industry:</b> <i>Industrial</i>
<b>Scope:</b> <i>Potable Water Tank Repair</i>	<b>Date:</b> <i>October 2013</i>
<b>Location:</b> <i>UK</i>	<b>Product:</b> <i>Epo-chem™ RS 500P &amp; RA 500M</i>

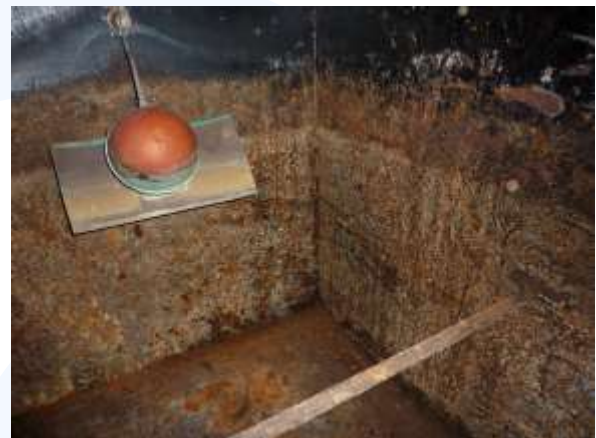
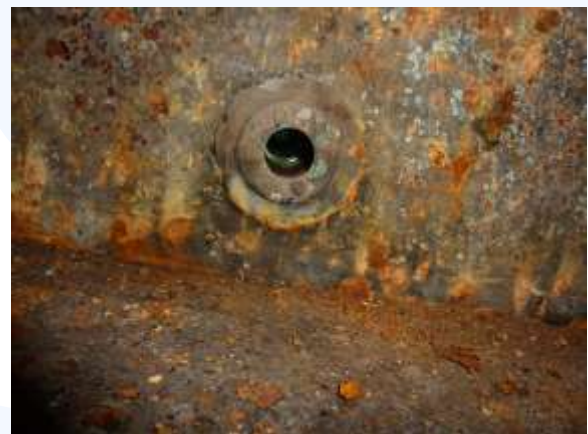
Although the school's potable water tanks were relatively new (only a few years), the existing bitumen coating had failed.

- Nos. 1 and 2 Before application

Manual preparation was selected as the surface preparation method. One primer coat of **solvent-free, wet & rust tolerant Epo-chem™ RS 500P** was applied first. This was followed by two topcoats of **solvent-free, wet tolerant Epo-chem™ RA 500M**.

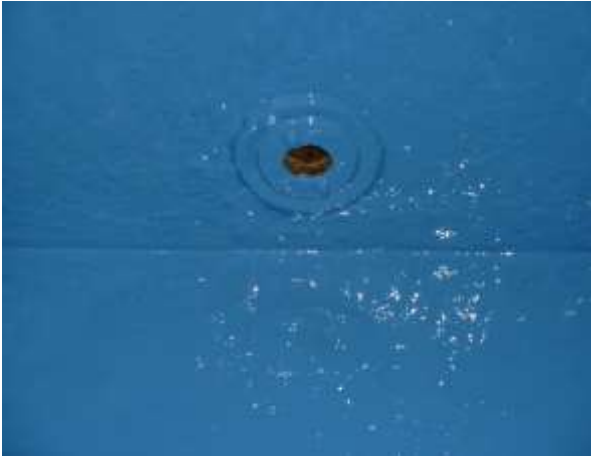
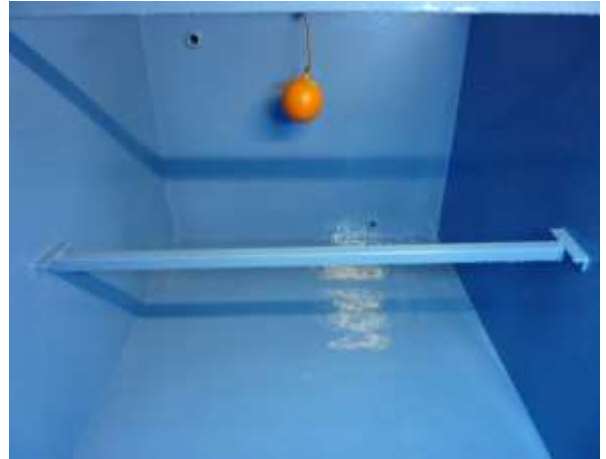
- Nos. 3 and 4 Completed application

The work was completed within three working days with **the tanks being restored to "as good as new" condition**, extending their practical working life. This resulted in substantial cost savings for the client as the cost of replacing the tanks far outweighed the cost of relining them.
