RB300 Series for Impeller

Substrate Cast iron Impeller

Products Chemco RB300AR Series

Environment Sewerage Treatment

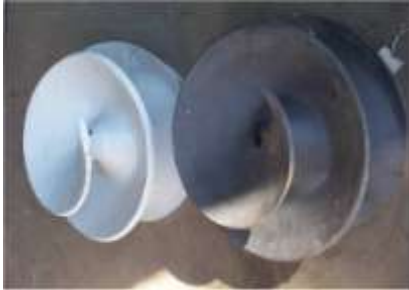
Refurbished on the left and new uncoated Impeller on the right

Chemco's Solution Using an original impeller the dimension of the un damaged profile was copied, using this stencil a composite repair was achieved within millimetres. With a combination of Kevlar reinforcing using hand laminated techniques and Chemco RB300AR, a glass-flake, silicon carbide filled Vinyl ester was applied, at 2000 micron nominal thickness and balance to required grade. This system has excellent resistance to corrosive/erosive environments.

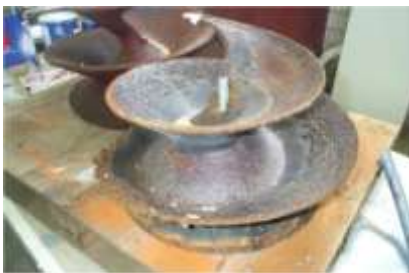
Old throw away impeller

Challenge The client had an old impeller where corrosion/erosion destroyed the impeller profile, severely reducing pump performance increasing operating costs.

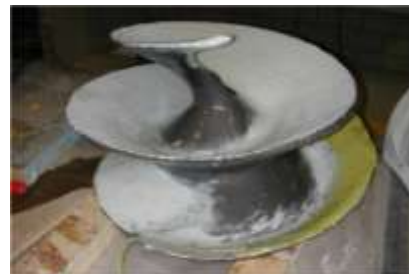
Kevlar reinforcing added

Scope RB300 (AR) to rebuild surfaces
Kevlar to improve strength
RB300 (AR) application to achieve desired thickness
Post cured at 80°C for 8 hours to improve chemical and abrasion resistance
Final machining to original dimension and tolerances using a PCD (poly carbonate diamond) tip.

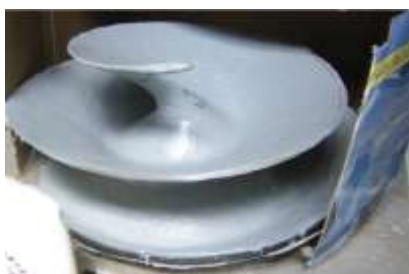
Post cure

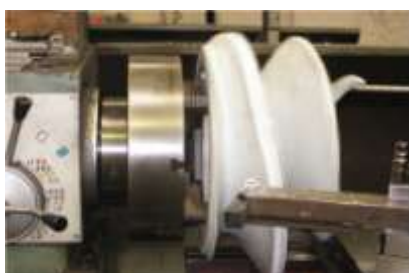
Final machining to original dimensions and tolerances
