Client: <i>Marine & Industrial Pump Repair (Gulf)</i>	Industry: <i>Marine</i>
Scope: <i>Pump Repair</i>	Date: <i>January 2007</i>
Location: <i>UK</i>	Products: <i>Epo-chem™ RA 564 & Ceram-chem™ RH 500 & RP 500</i>

A number of large pumps had to be refurbished, most of which are suffering from stress corrosion and cavitation.

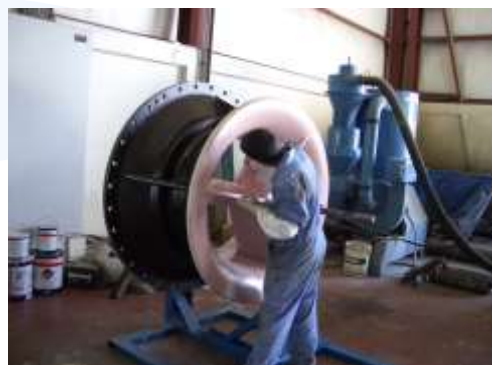
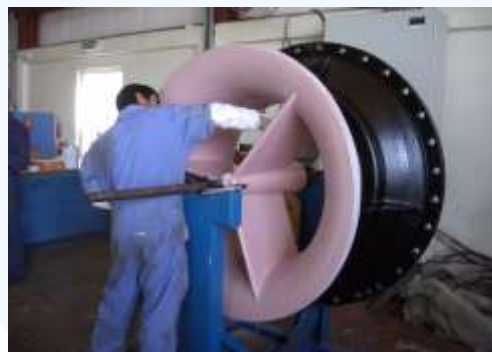
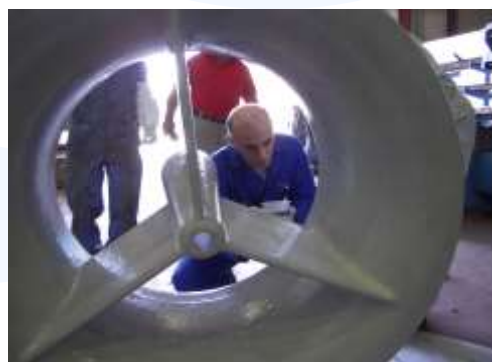
- Nos. 1-3 Application in Progress

Metal stitching using **Ceram-chem™ RH 500** (metal putty), **Epo-chem™ RA 500 series** and **Ceram-chem™ RP 500** topcoats.

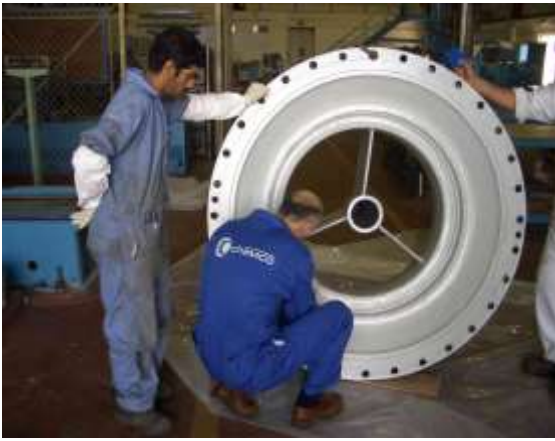
- No. 4 Application in Progress
- Nos. 5-7 Before Application
