<b>Client:</b> <i>Scottish Power</i>	<b>Industry:</b> <i>Power Generation</i>
<b>Scope:</b> <i>Spiral Casing</i>	<b>Date:</b> <i>November 2002</i>
<b>Location:</b> <i>UK</i>	<b>Products:</b> <i>Epo-chem™ RA 564 &amp; Ceram-chem™ RH 500 &amp; RP 500</i>

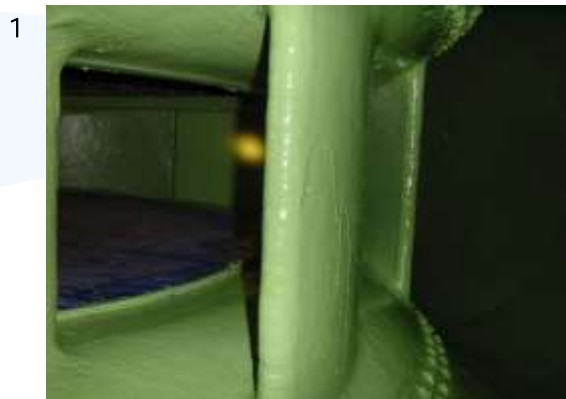
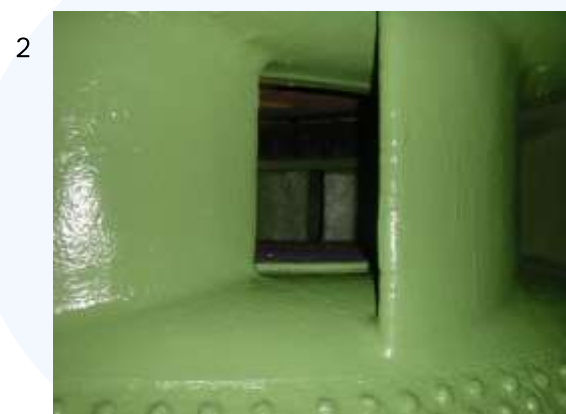
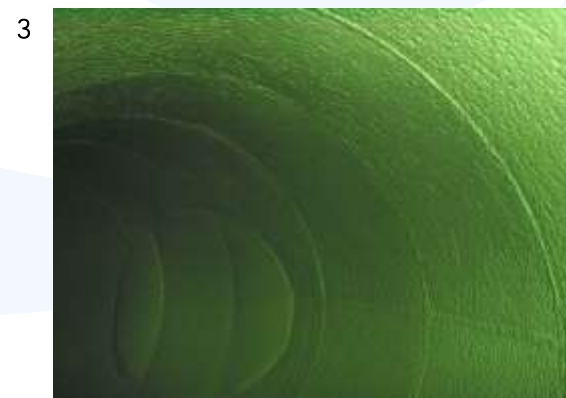
### Photographs:

- Nos. 1-3 Spiral Casing After Application

First coat of **Epo-chem™ RA 564 solvent-free** glass-flake epoxy @ 250µ by airless spray and brush. All severe areas of pitting were filled with **Ceram-chem™ RH 500 solvent-free**, high density epoxy putty. Second coat of **Ceram-chem™ RP 500 solvent-free**, ceramic epoxy system @ 200µ by airless spray and brush.

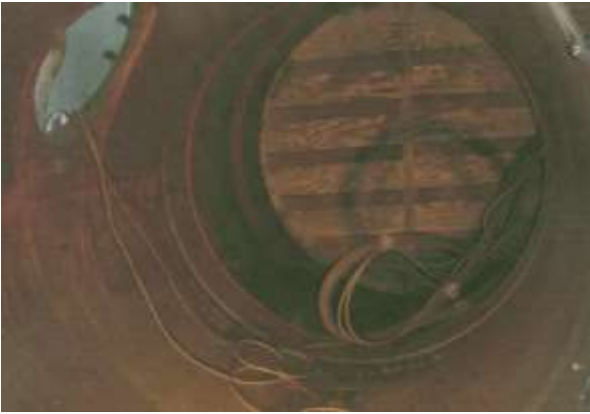
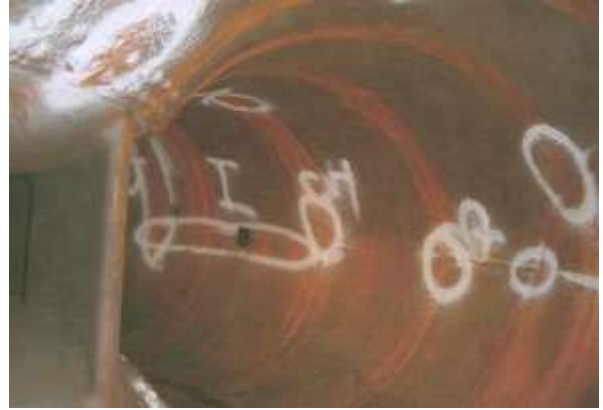
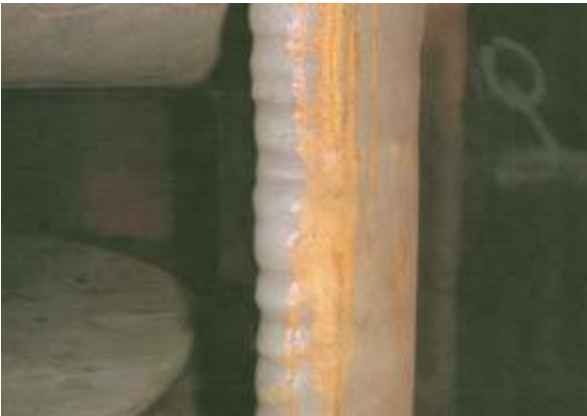
Photographs:

Working within a very tight timescale, severe pitting and corrosion, extremely high humidity, confined space, water ingress and other contractors working adjacent to the spiral refurbishment added to the difficulty of the project.

- Nos. 4-6 Spiral Casing Before Application
